IMPACT RESISTANCE OF
COMPOSITE FAN BLADES

E. J. PREMONT
K. R. STUBENRAUCH

PRATT & WHITNEY AIRCRAFT
DIVISION OF UNITED AIRCRAFT CORPORATION

1. Report No. NASA CR-134515	2. Government Accession No.	3. Recipient's Catalog No.	
4. Title and Subtitle Impact Resistance of Composite Fan Blades Final Report		5. Report Date May 1973

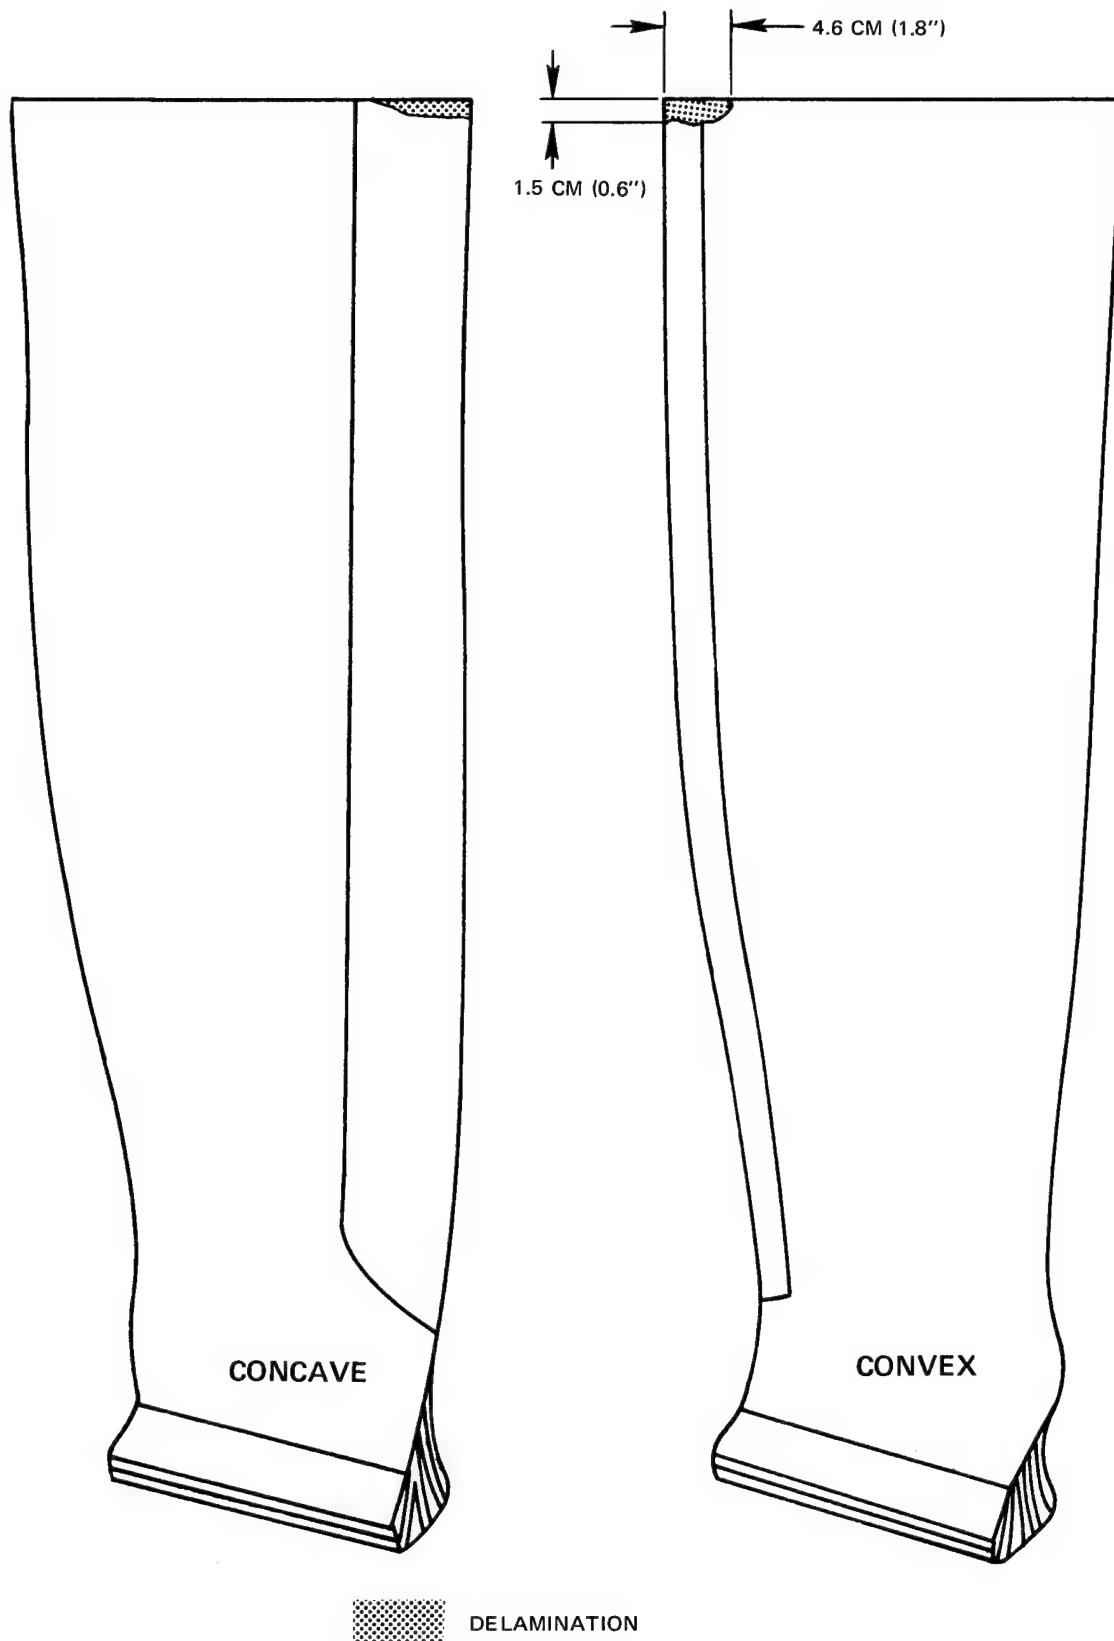
Figure 23 Visual Damage to Graphite/Epoxy Blade C-1 Following Impact with Ice Ball

In the 5.1 cm (2.0 in) diameter ice ball impact tests of blades C-1 and B-1, the high speed movies showed that the ice ball shattered upon contact with the blade leading edge in each case. Visual damage to the two blades after impact with the 75g (2.6 oz) ice balls is shown schematically in Figures 23 and 24 and pictured in Figures 25 and 26. The small area of composite delamination on blade C-1 was in the area where ultrasonic indications of poor consolidation was found during pre-test NDI. This ultrasonic area grew during testing, as shown in Figure 27. The tip deflection caused by the impact tends to further loosen any existing delamination. Due to the designed thinness of the composite at the blade tip leading edge, the impact has an increased effect on this area.

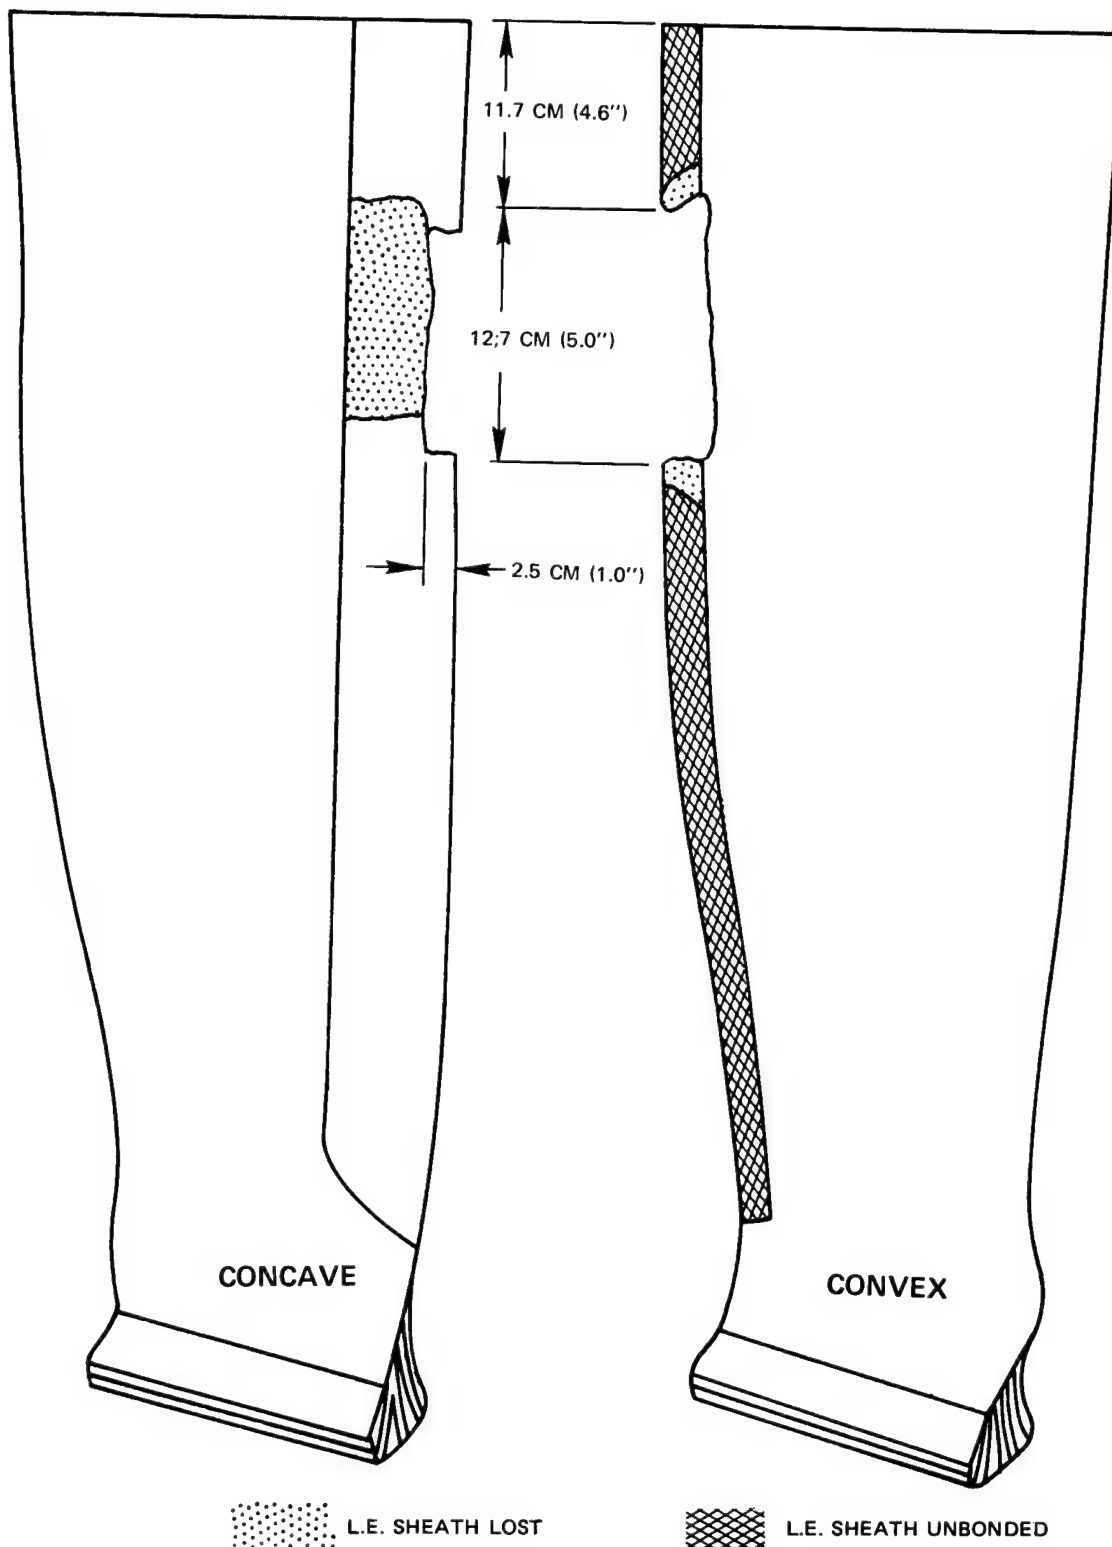
Figure 24 Visual Damage to Boron/Epoxy Blade B-1 Following Impact with Ice Ball

The damage to blade B-1 from the ice ball impact was more severe, however, no post-test ultrasonic indications were found. High speed movies show that blade B-1 took a large slice of the ice ball (approximately three-quarters of the ball), whereas blade C-1 hit the ice ball at its mid-point. This seems to be the only factor which affected the amount of damage sustained by each blade. The difference in FOD was not expected due to the composite material differences. The FOD threshold is very likely close to the ice ball weight of 75g (2.6 oz).

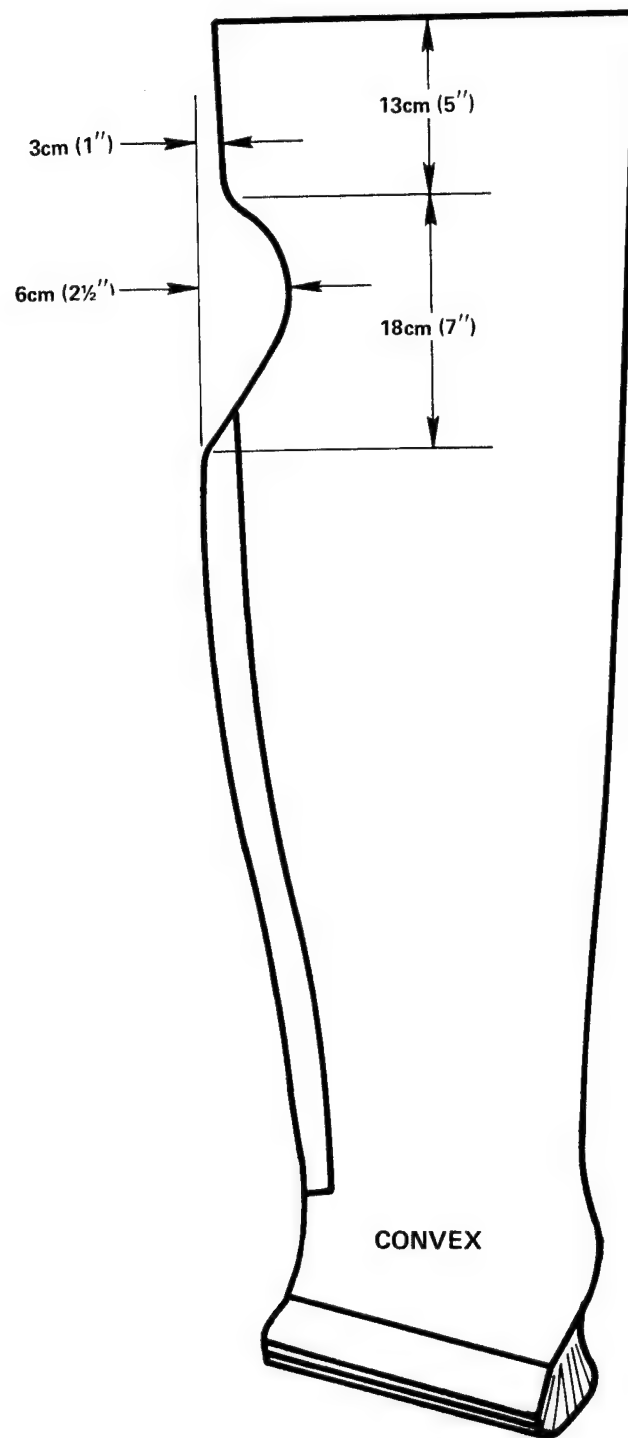
Figure 29 Estimated Damage to Graphite/Epoxy Blade C-2 Following the First Impact with 320g Gelatin Ball

The 320g (11.2 oz) gelatin ball impact caused damage to graphite/epoxy blade C-2 as sketched in Figure 29 estimated from the final sequence photo of Figure 28. The high-speed movies revealed that the slice size for this first impact was approximately 110g (3.8 oz). In this test, the object catching system failed to prevent a second impact. The remaining 210g (7.4 oz) piece of gelatin ball hit the blade inboard of Section K-K where the airfoil chord angle is greater. The damage from both impacts is sketched in Figure 30 and pictured in Figure 31. Post-test ultrasonic indications correspond to the delaminated area shown in Figure 30.

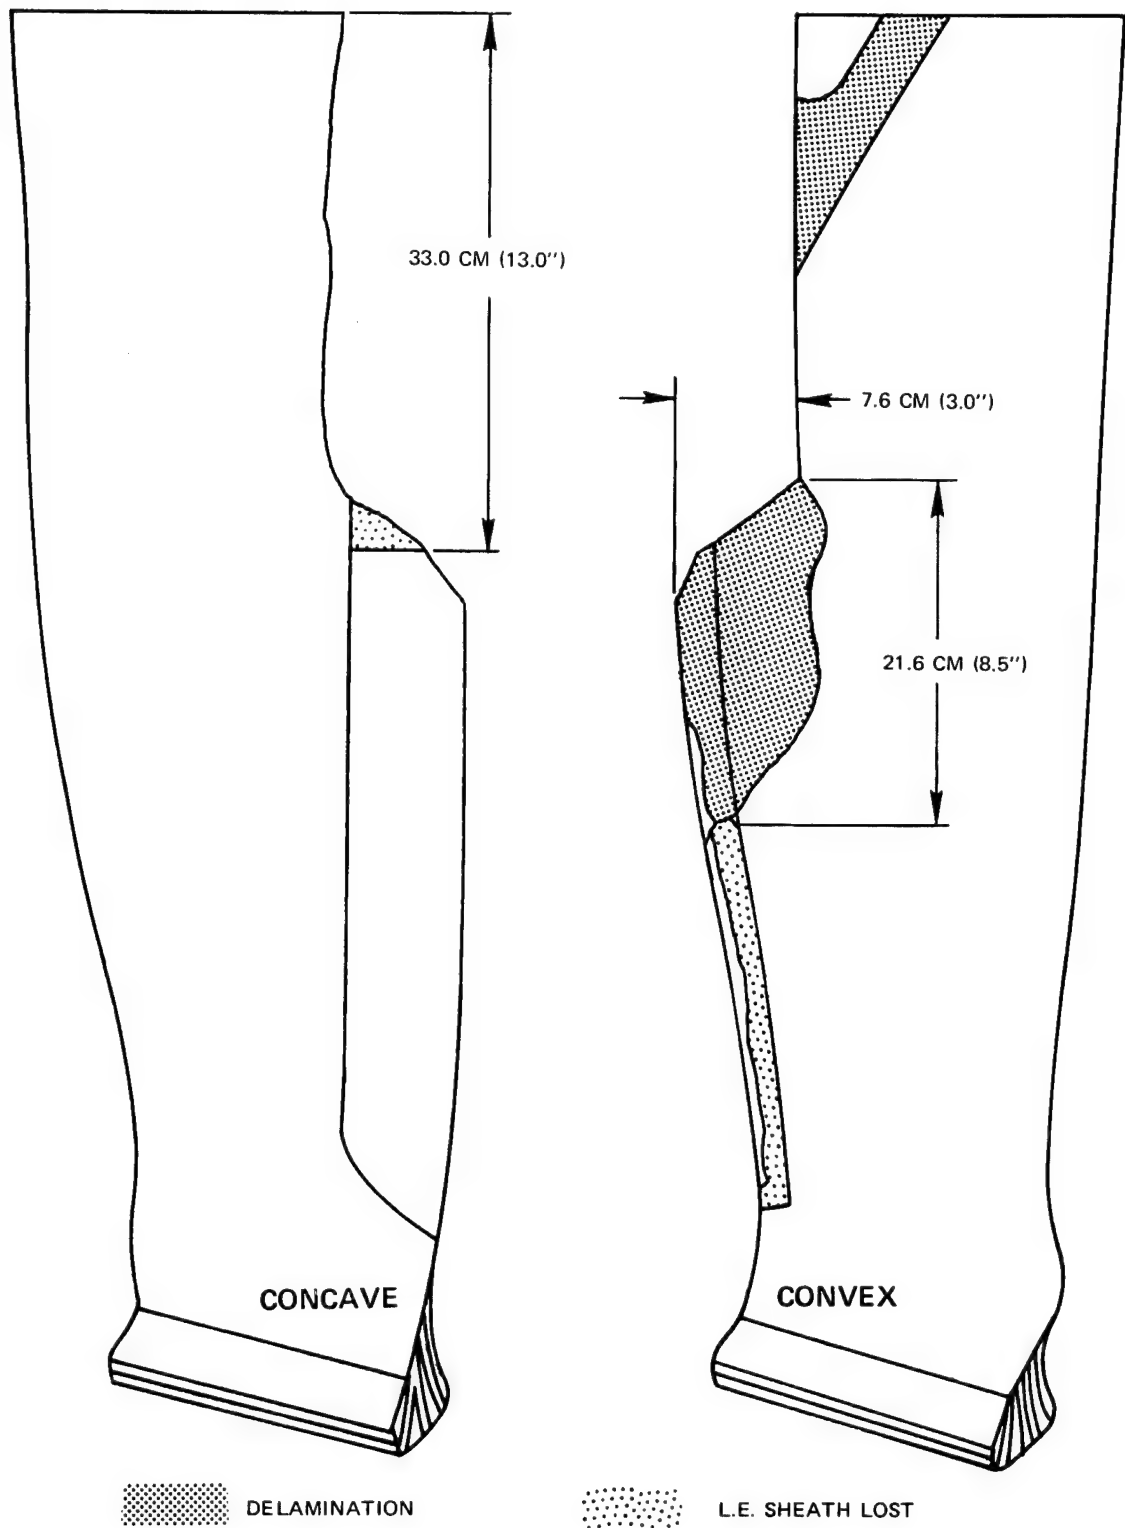
Figure 32 Visual Damage to Graphite/Epoxy Blade C-3 Following Impact with 165g Gelatin Ball

Blade C-3 sliced 105g (3.7 oz) from the 165g (5.8 oz) gelatin ball which impacted the blade leading edge at Section K-K. Visual damage is shown in Figures 32 and 33. Ultrasonic indications after testing were in the areas labeled as delamination in Figure 32.

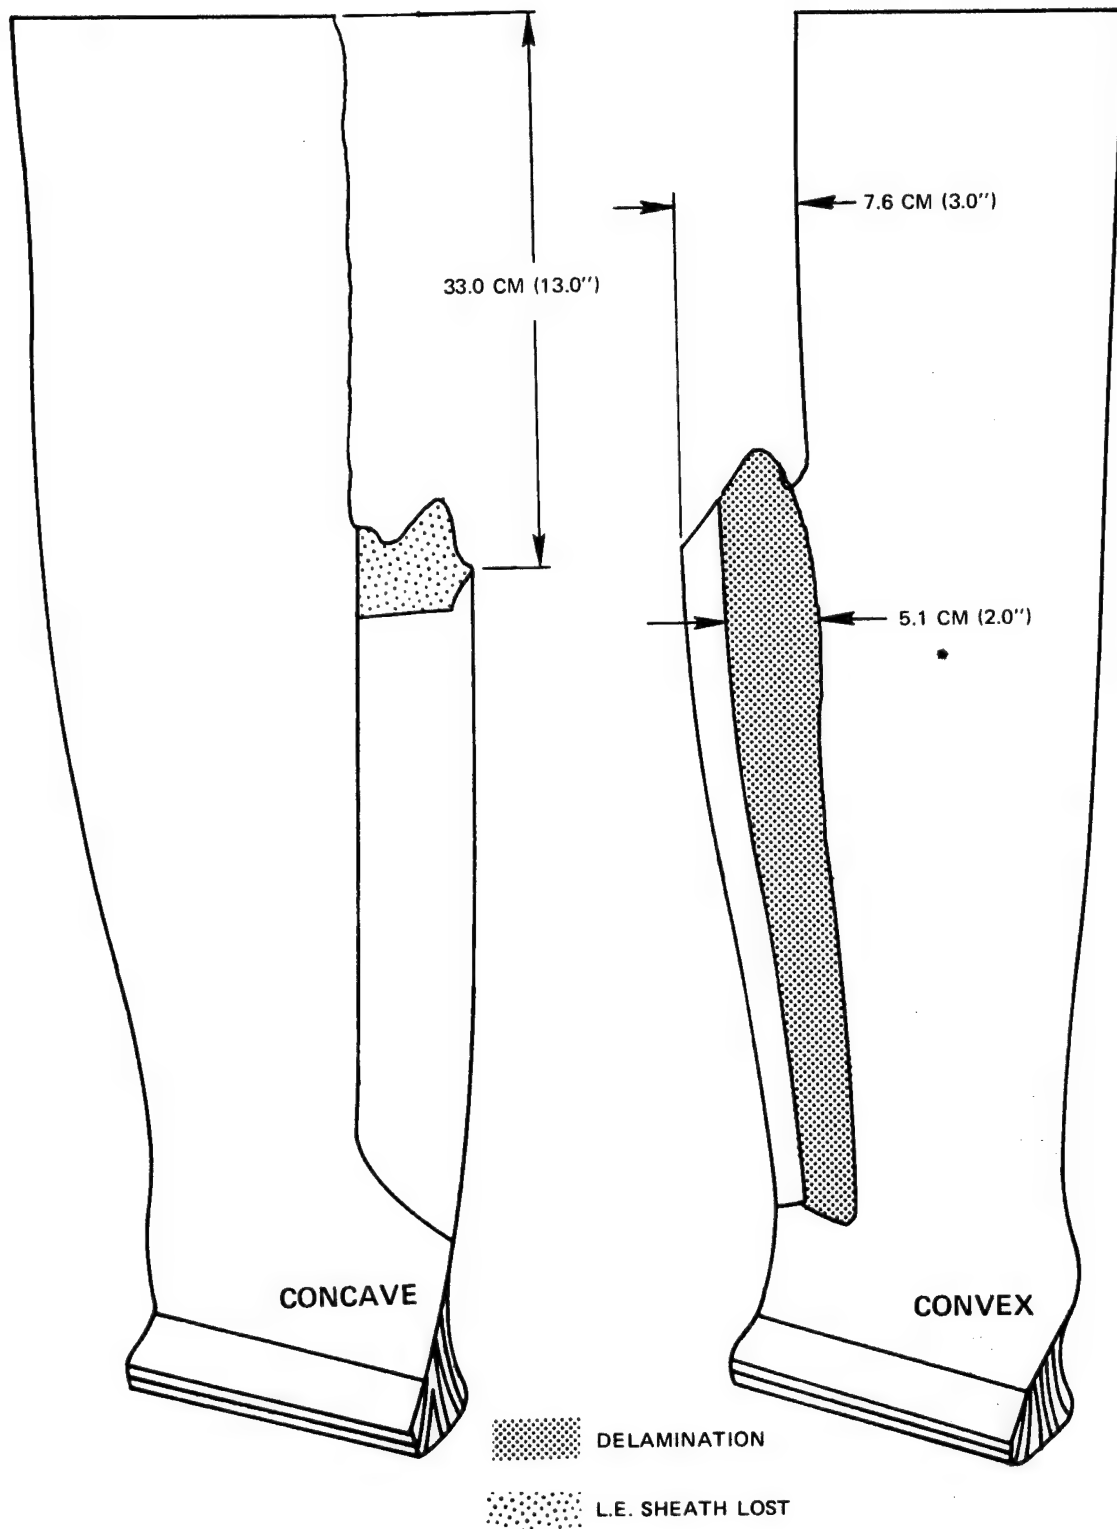
Figure 34 Visual Damage to Boron/Epoxy Blade B-2 Following Impact with 320g Gelatin Ball

In the test of boron/epoxy blade B-2, a slice greater than one-half of the 320 g (11.2 oz) gelatin ball was taken. The 210g (7.4 oz) slice impact caused the damage shown in Figures 34 and 35. No ultrasonic indications were found on blade B-2 following testing.

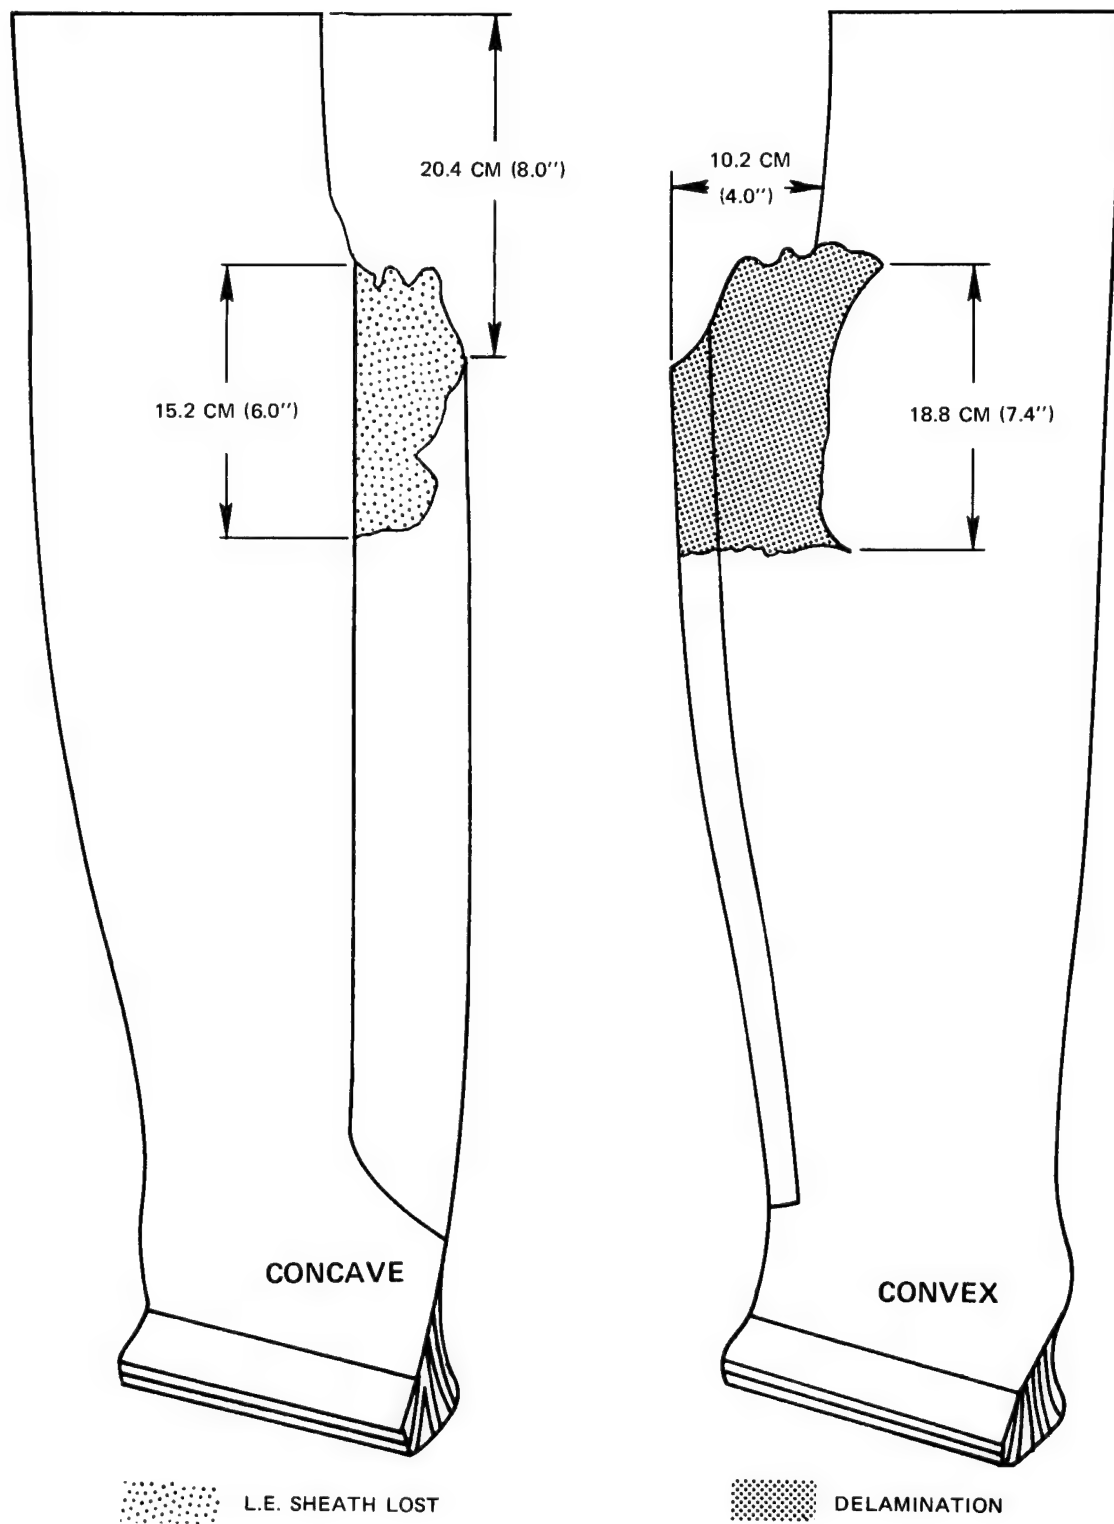
Figure 36 Visual Damage to Boron/Epoxy Blade B-3 Following Impact with 165g Gelatin Ball

Boron/epoxy blade B-3 was impacted with a 165 g (5.8 oz) gelatin ball, however, a malfunction in the drop mechanism caused only a 25g (.9 oz) slice to be taken. The blade was visually and ultrasonically inspected following this impact and found to be undamaged. Blade B-3 was then retested with a new 165g gelatin ball. A 130g (4.6 oz) slice was cut from this ball and blade damage did occur as shown in Figures 36 and 37. Post-test ultrasonic indications correspond to the area shown as delaminated in Figure 36.

The FOD threshold for boron/epoxy blades was determined to be below a 130g (4.6 oz) gelatin ball slice size from the B-3 impact test. However, the severity of damage with the 210g (7.4 oz) slice taken by blade B-2 was not significantly worse than the B-3 damage.

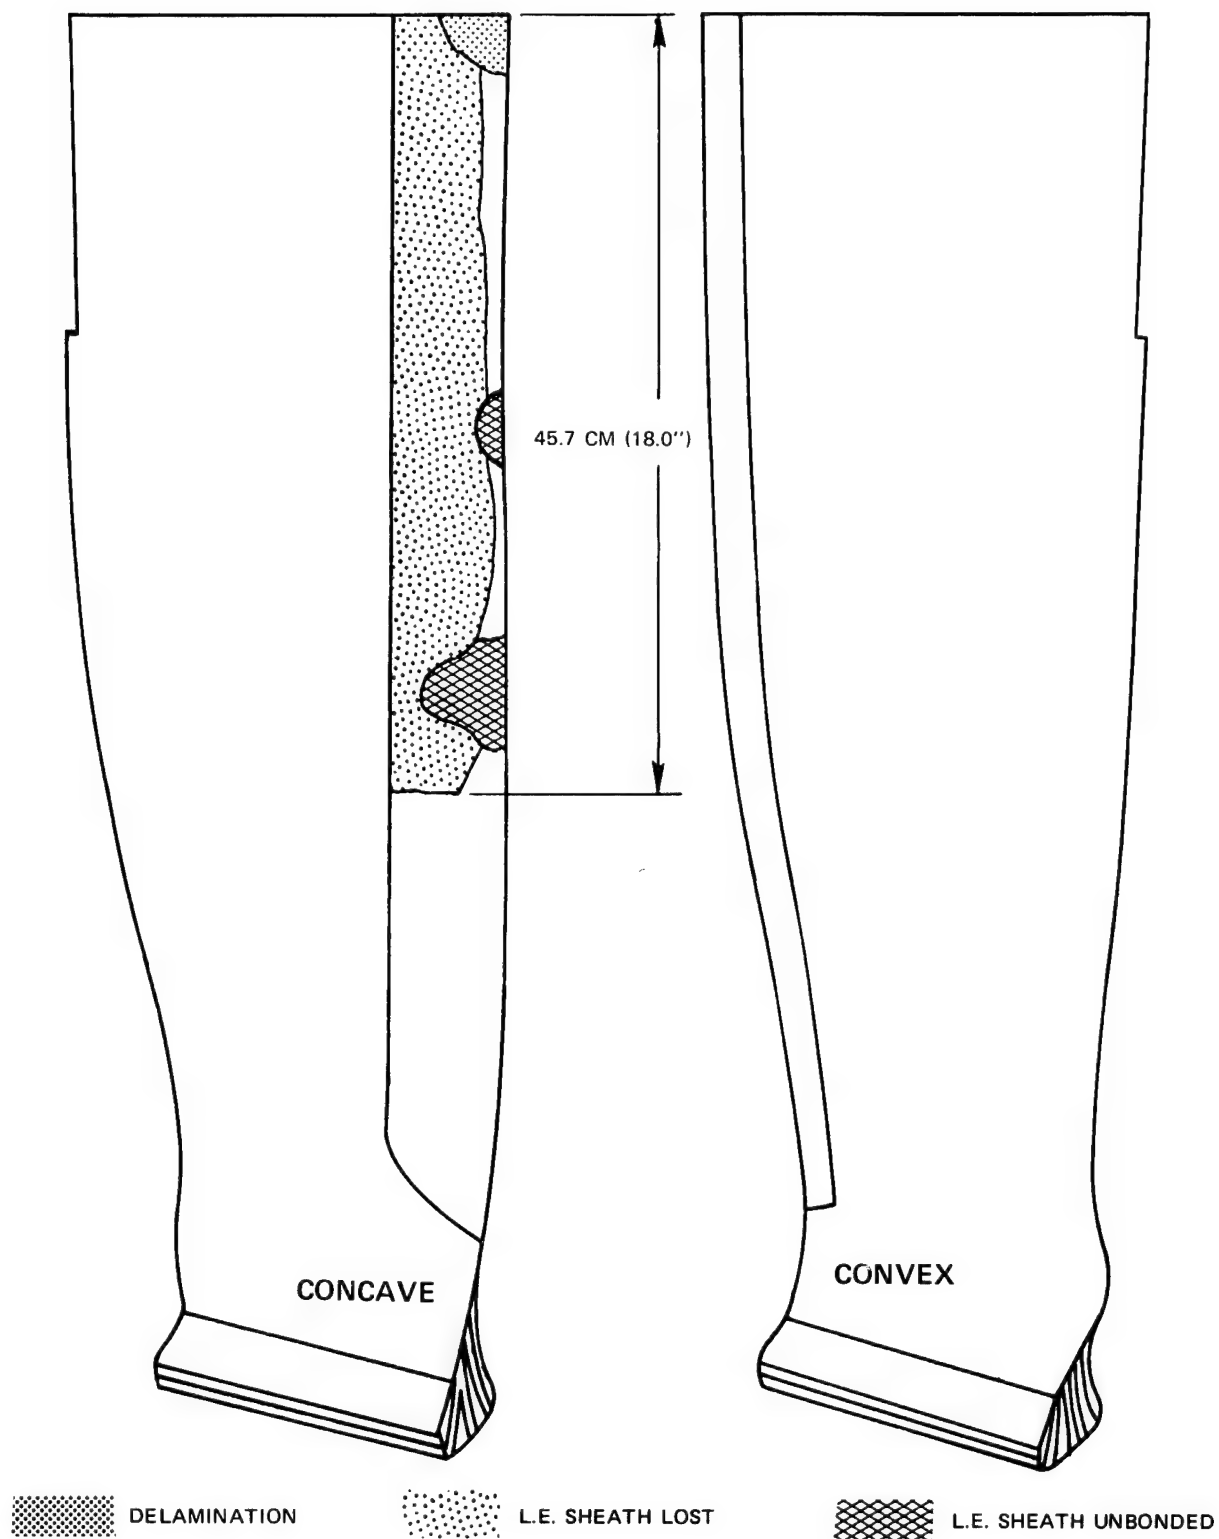
Figure 44 Visual Damage to Graphite/Epoxy Blade C-4 Following Impact with Gravel

Blade C-4 and B-4 were each impacted with 30g (1.1 oz) of gravel. The leading edge sheath on the concave side of C-4 came off the blade as shown in Figures 44 and 45. This failure indicates the possibility of a poor bond between the blade and sheath, although pre-test NDI showed no lack of bonding. Post-test ultrasonic inspection showed indications in the two areas illustrated in Figure 46.

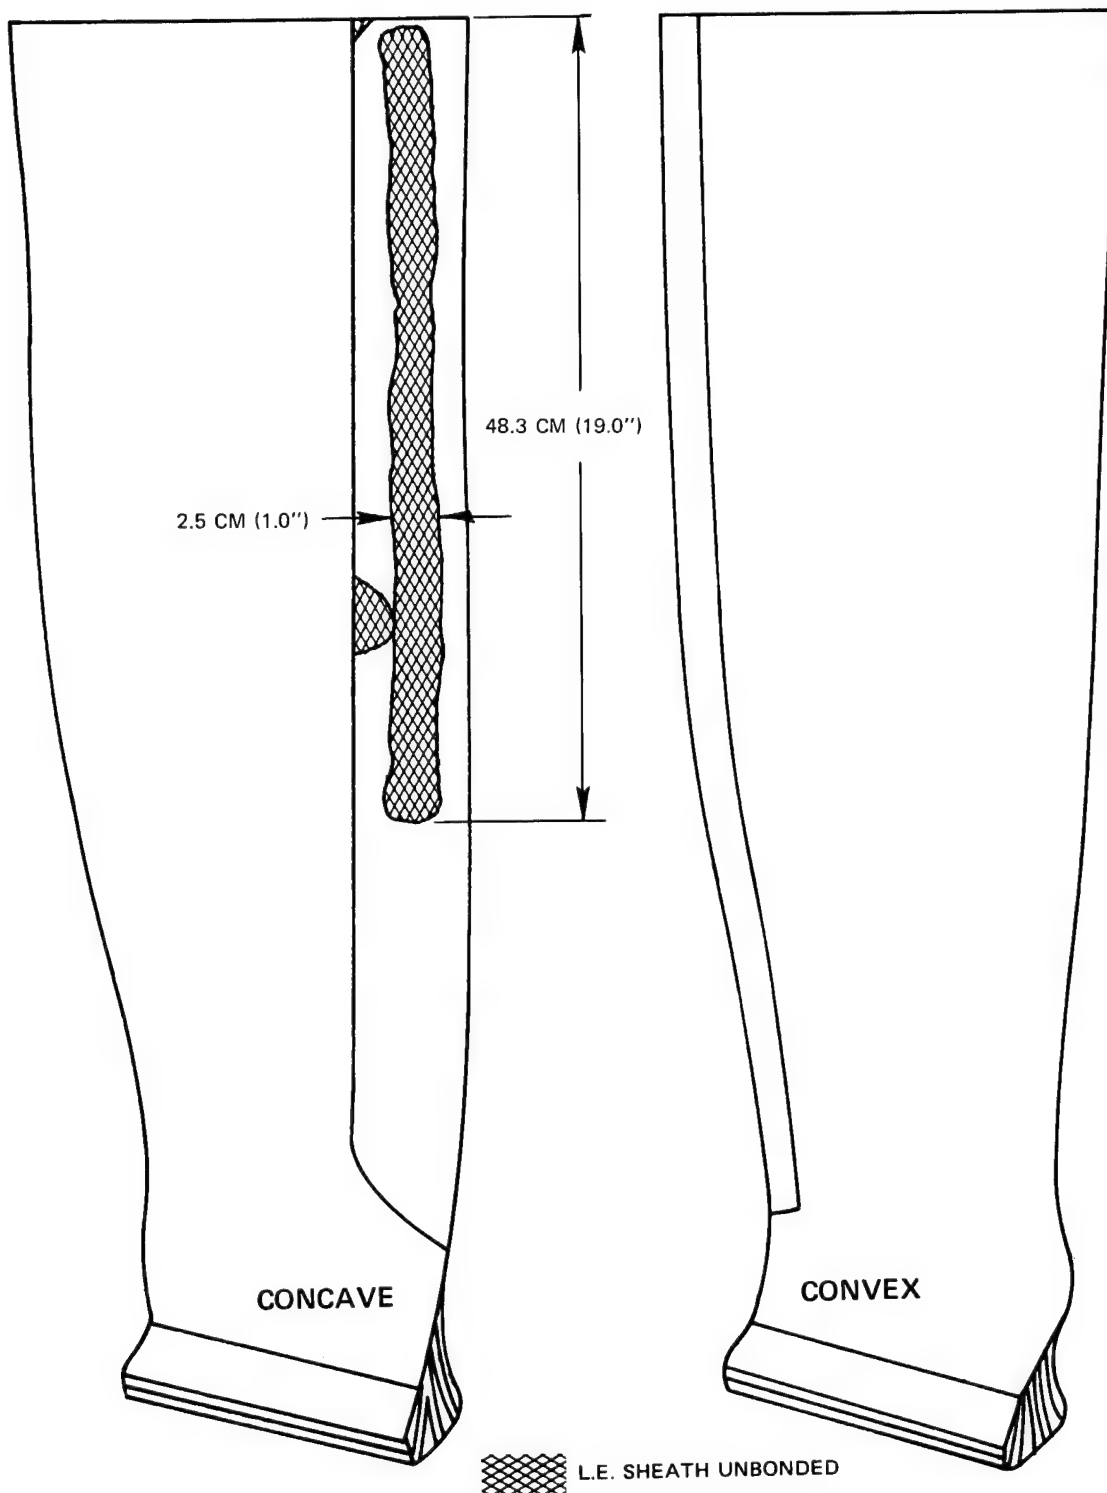
Figure 47 Visual Damage to Boron/Epoxy Blade B-4 Following Impact with Gravel

The gravel impact results on blade B-4 are shown in Figures 47 and 48. No ultrasonic indications were found after testing. Damage at the leading edge is negligible, even though the high-speed movies show that impacts did occur at this location. However, the concave side sheath, aft of the leading edge, was nicked, gouged, and unbounded, as pictured in Figure 49. The gravel apparently strikes the sheath causing compressive stresses on the sheath exterior surface. The stress differential within the sheath is great enough to break the sheath-to-blade bond and then lift the sheath from the surface of the blade. Therefore it is concluded that with a better bond between sheath and blade, the leading edge sheath could offer satisfactory protection from small amounts of gravel ingestion.

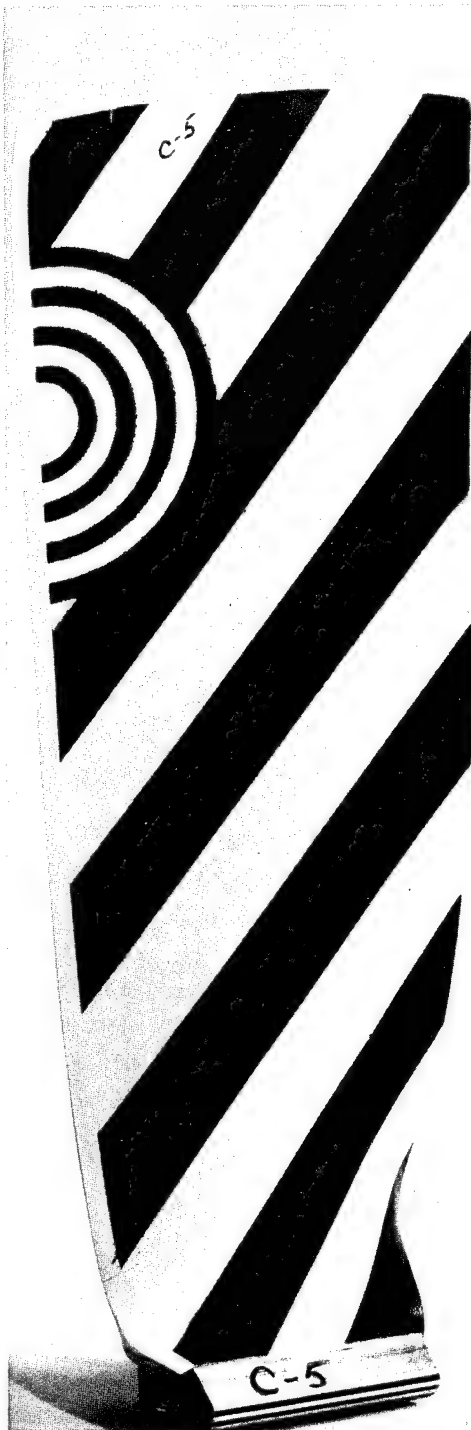
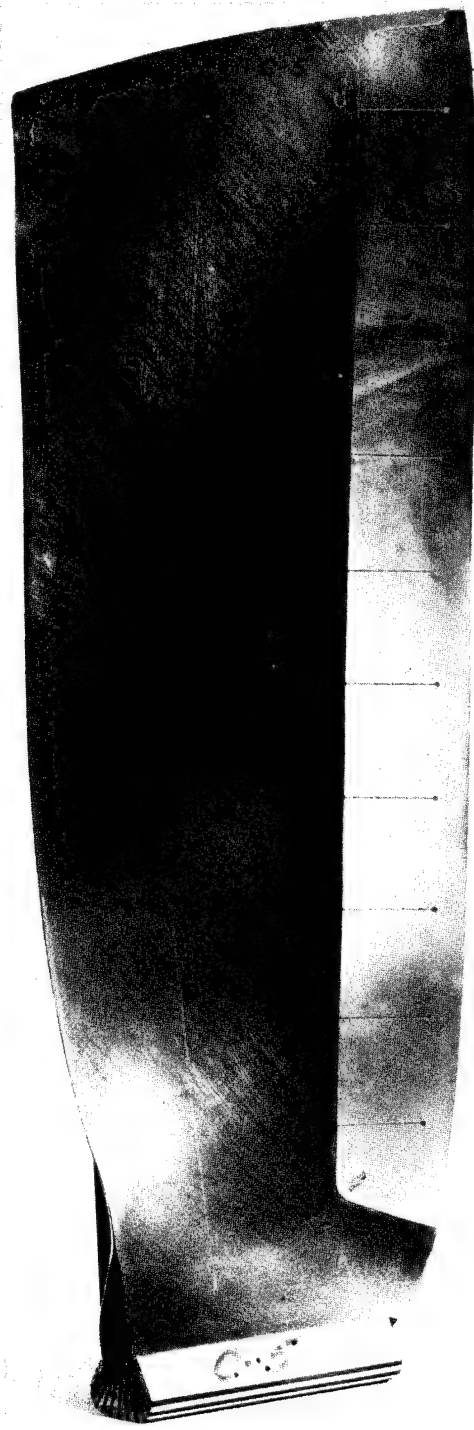
Figure 50 Graphite/Epoxy Blade C-5 Following Impact with 75g Starling

Blade C-5 and B-5 were impacted with 75g (2.6 oz) and 80 g (2.9 oz) starlings, respectively. The 40g (1.4 oz) slice taken by C-5 and the 45g (1.6 oz) slice cut by B-5 caused only slight damage in each case. The damage which occurred seems to be related to blade fabrication problems. Both blades are pictured in Figures 50 and 51 respectively.

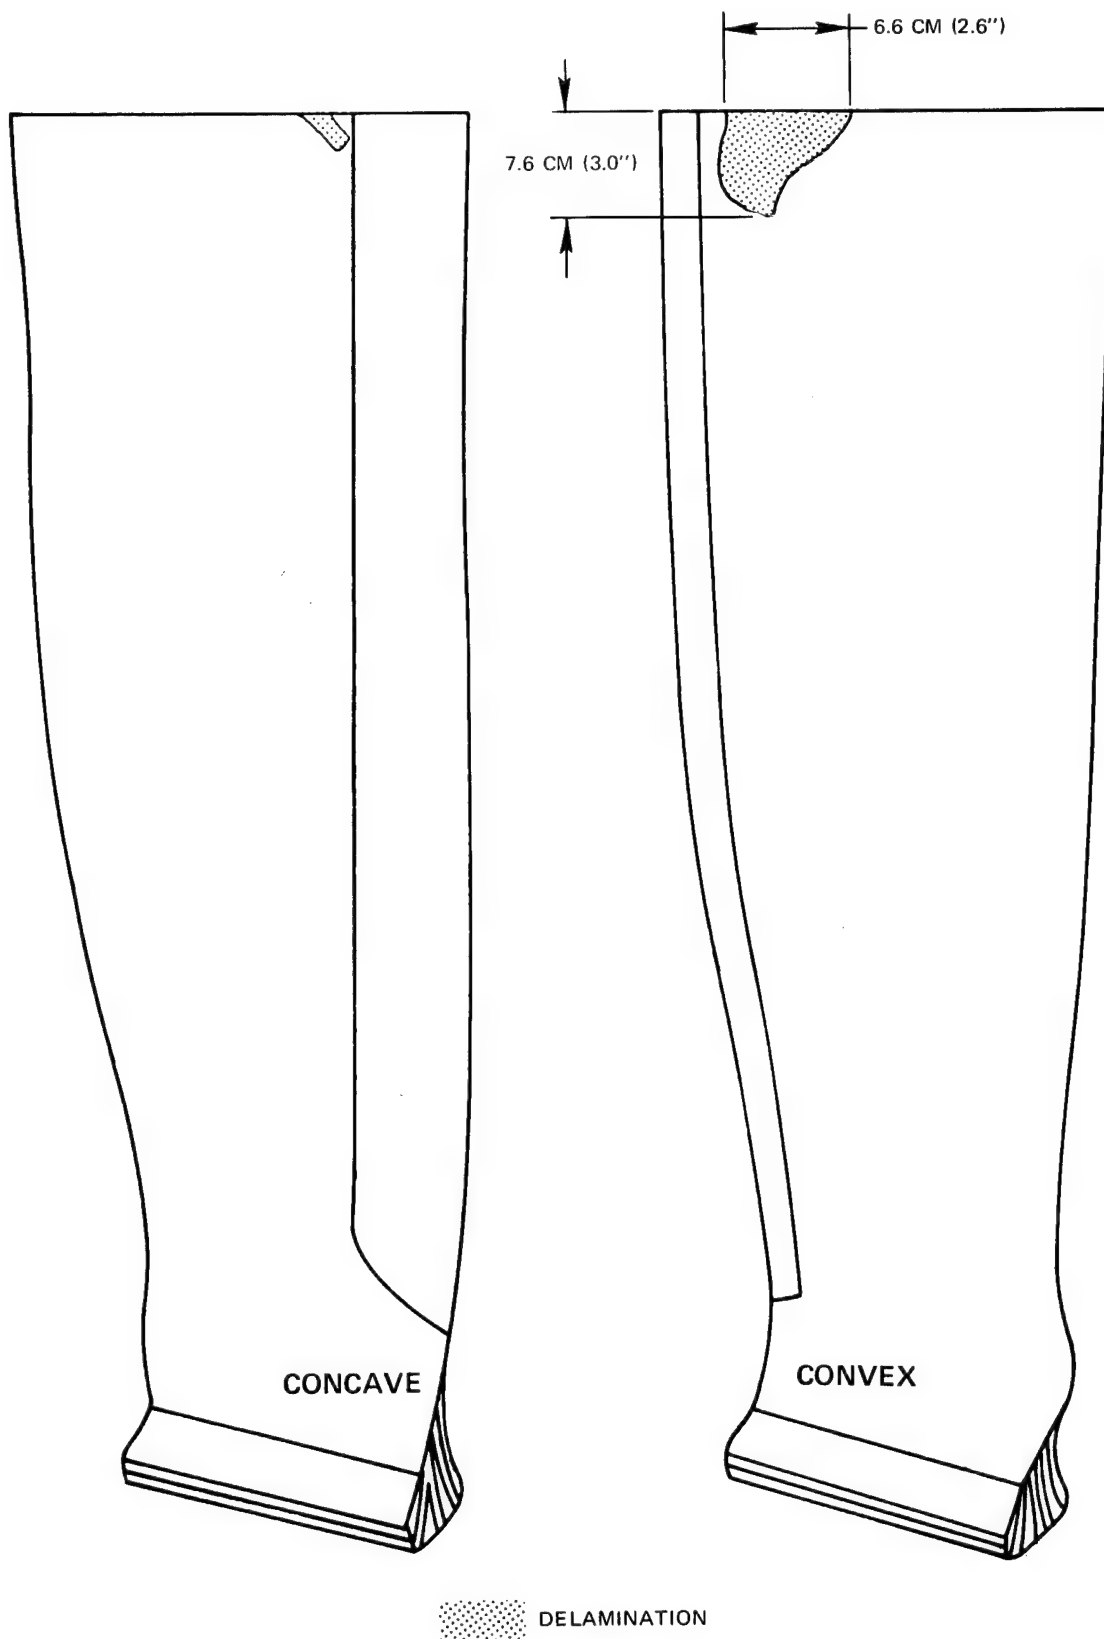
Figure 52 Visual Damage to Graphite/Epoxy Blade C-5 Following Impact with Starling

The visually delaminated area of C-5 shown in Figure 52, which also corresponds to post-test ultrasonic indications, is in a location where a pre-test ultrasonic indication was present. The starling impact caused this area of delamination to grow. If the blade had been well consolidated in this area, possibly no damage would have occurred from the impact.

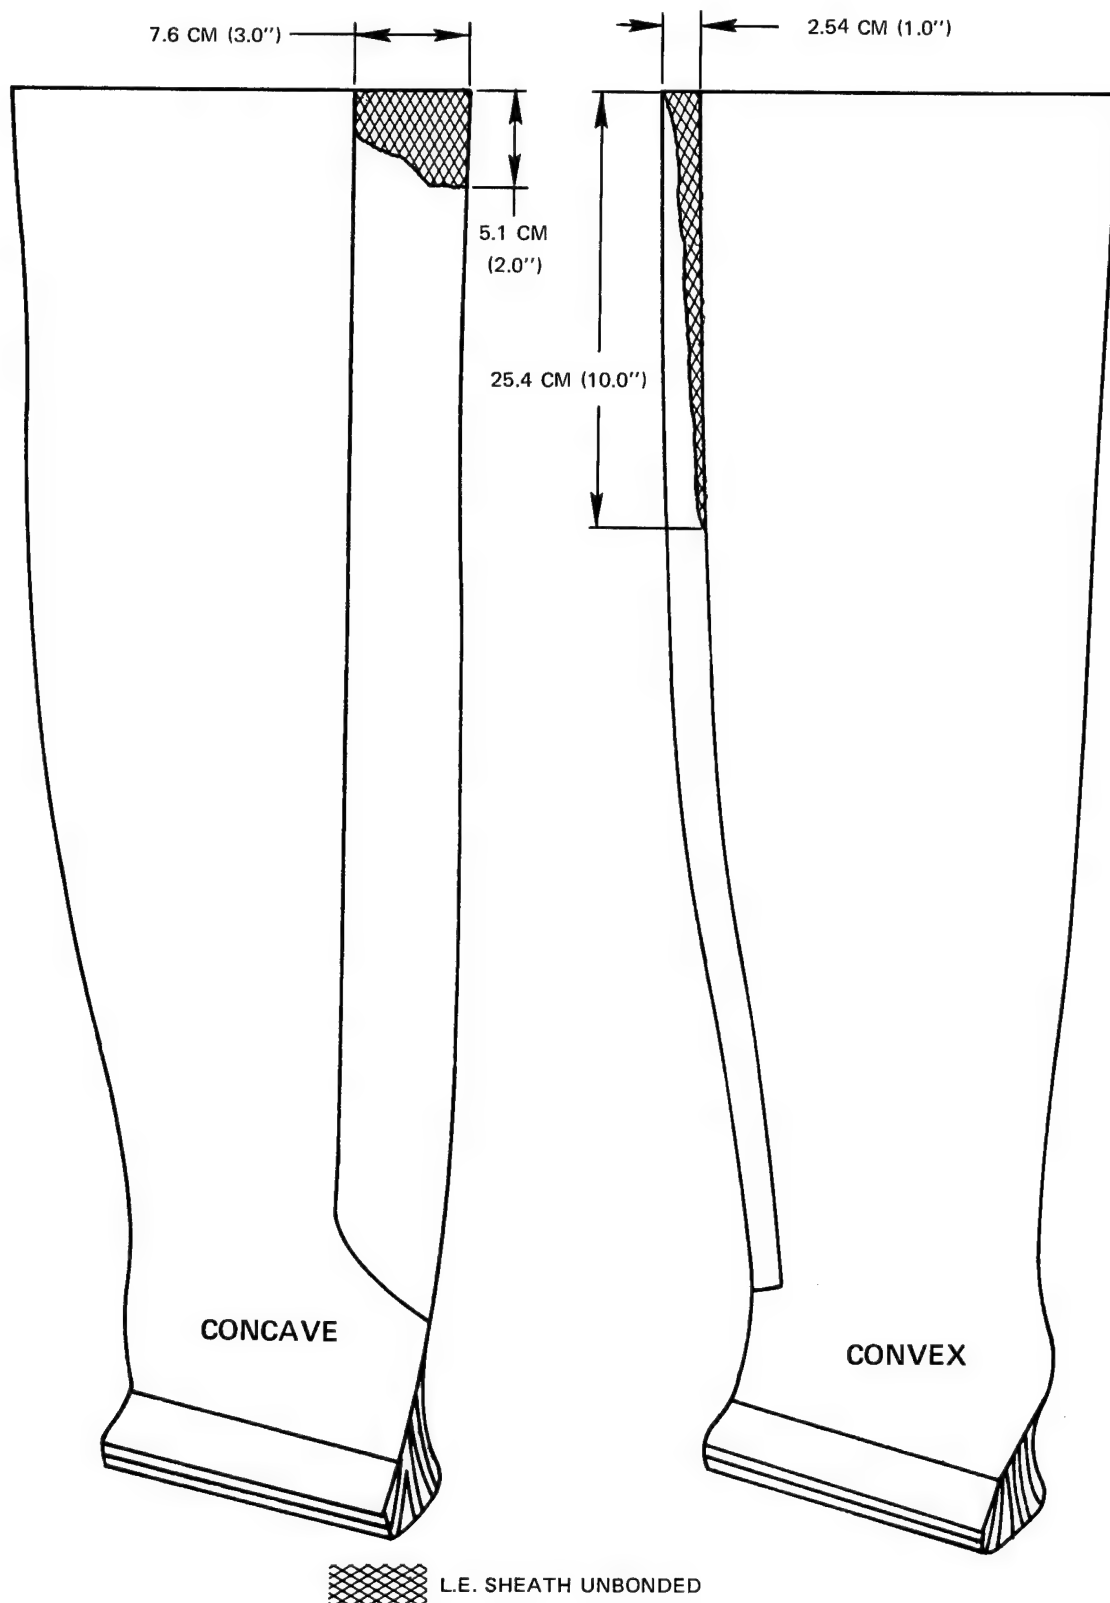
Figure 53 Visual Damage to Boron/Epoxy Blade B-5 Following Impact with Starling

Only a small amount of leading-edge sheath unbonding, as shown in Figure 53, resulted from B-5 starling impact. Better bonding of the sheath to the blade could perhaps prevent such damage. No post-test ultrasonic indications were found on this blade.

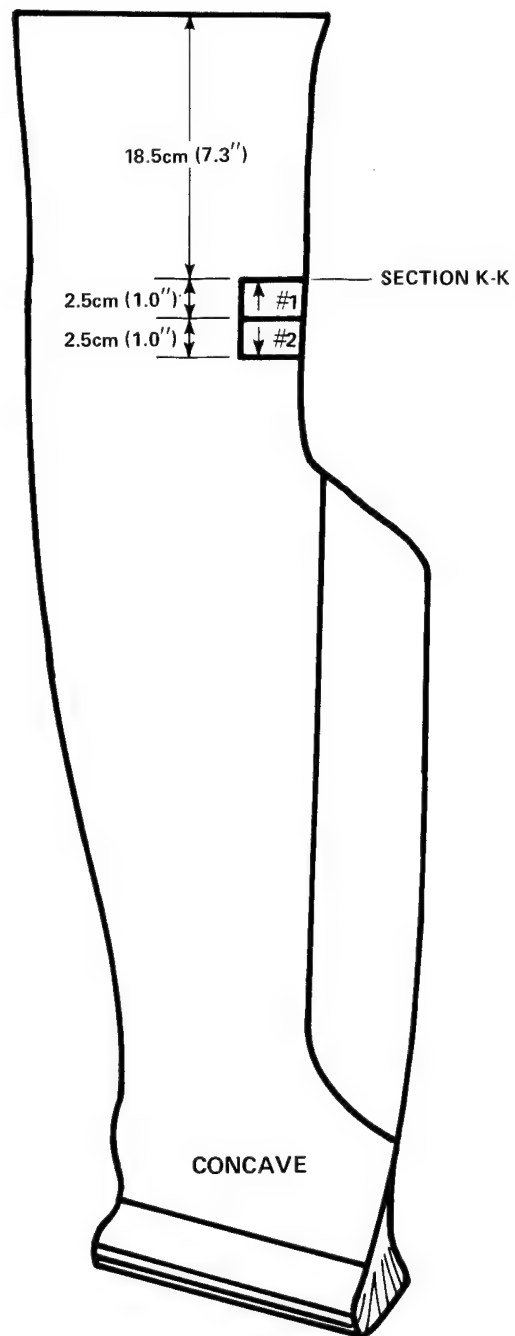
Figure 54 Metallographic Section Locations - Graphite/Epoxy Blade C-3

Graphite/epoxy blade C-3 was sectioned in the area of the impact damage for metallographic study. Two chordwise sections were examined, as illustrated in Figure 54. Section 1 revealed a shear crack of approximately .41 cm (.16 in) length angled at 40° from the concave blade surface as shown in Figure 55. Section 2, pictured in Figure 56, revealed five interlaminar separations which propagated for a length of .10 cm (.04 in) to .66 cm (.26 in) in the chordwise direction. No internal composite damage was found further away from the broken area of the blade.

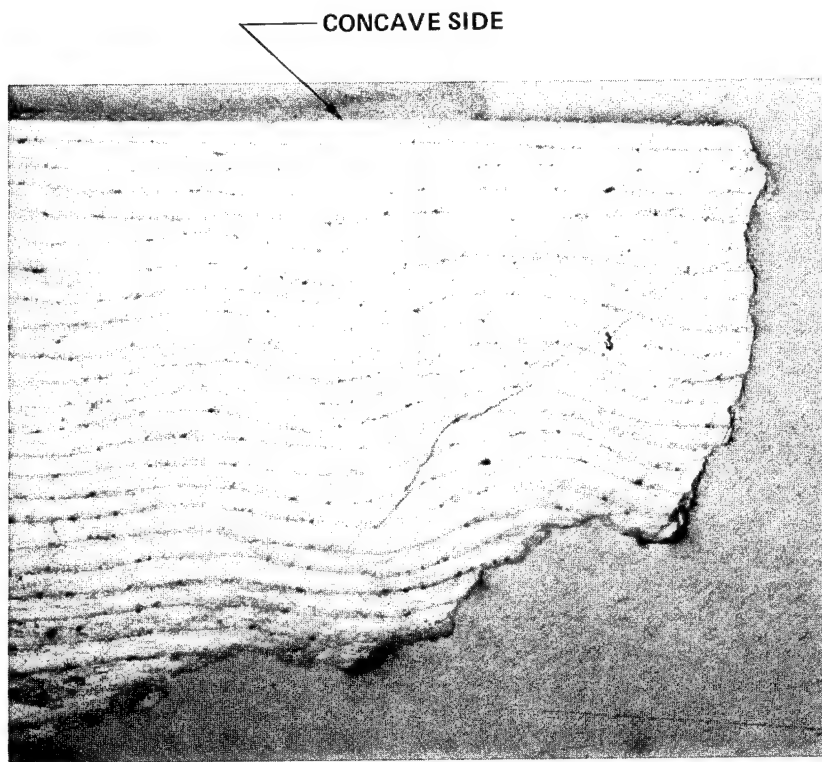
Figure 55 Photo-micrograph of Area 1, (Figure 54), of Graphite/Epoxy Blade C-3 Showing Shear Crack (15X)

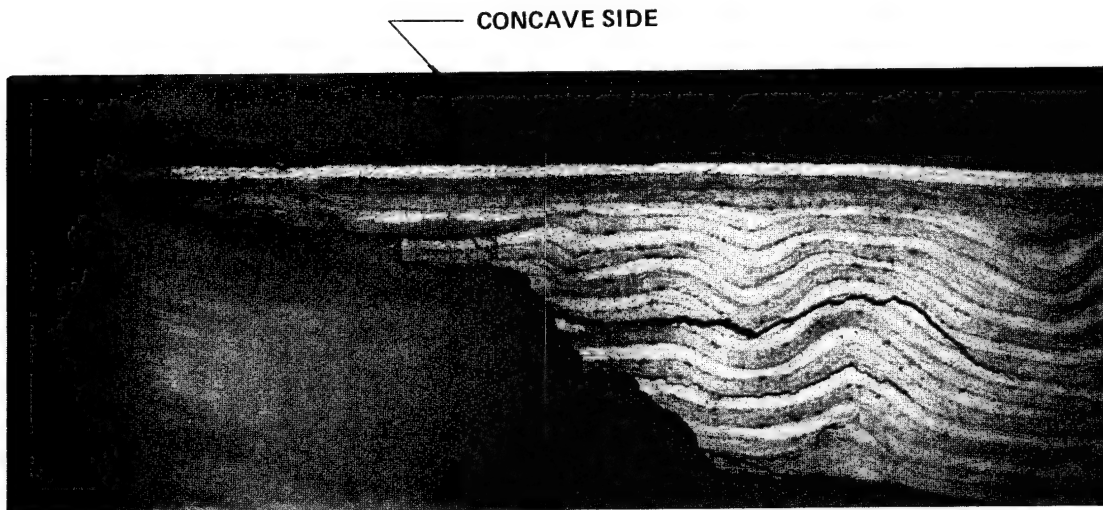
Figure 56 Photo-micrograph of Area 2, (Figure 54), Graphite/Epoxy Blade C-3 Showing Interlaminar Separations (13X)
